## NEVADA STATE MUSEUM HVAC REPLACEMENT

## NEVADA STATE MUSEUM FACILITY CONDITION ANALYSIS REPAIRS

**NEVADA STATE MUSEUM  
REMOVAL OF ASBESTOS FLOOR TILE  
18—25**

## EAST ELY RAILROAD MUSEUM SIDEWALK REPLACEMENT

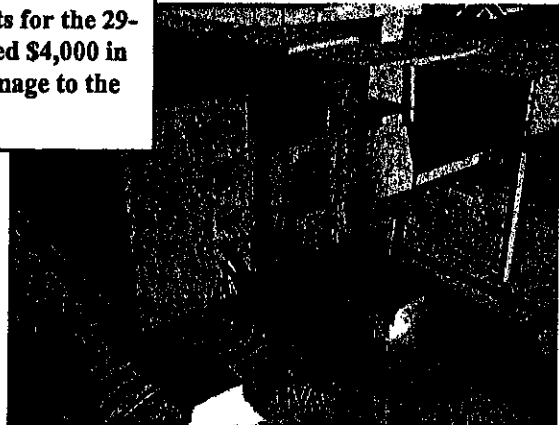
- Existing units 33 years old.
- Average annual cost now exceeding \$4,000 in repairs alone.
- Museum collections require minimal temperature changes to protect.
- Museum patrons count on climate controlled environment.
- Damage to roof as units continue to leak.

Average annual maintenance costs for the 29-year-old HVAC system now exceed \$4,000 in repairs alone. Leaking causes damage to the museum's roof.

Replace four existing roof mounted HVAC units in the Calhoun Wing of the Nevada State Museum. Existing system is 33 years old, well beyond the life expectancy of 20 years.

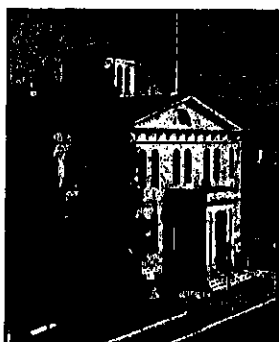
- 24 broken windows
- Exterior paint is peeling and fading
- Floor shingles missing
- Rusted and broken-away gutters

This project will address needed repairs to the Nevada State Museum in Carson City, including (left to right) cracked shingles, deteriorated exterior paint and 24 broken windows.

Major maintenance projects identified in a 1988 Facility Condition report have yet to be funded. The report identified several areas needing repairs, including broken windows, replacement of roof shingles and gutters, grouting the masonry walls, repairing loosening sandstone blocks and painting the building exterior.

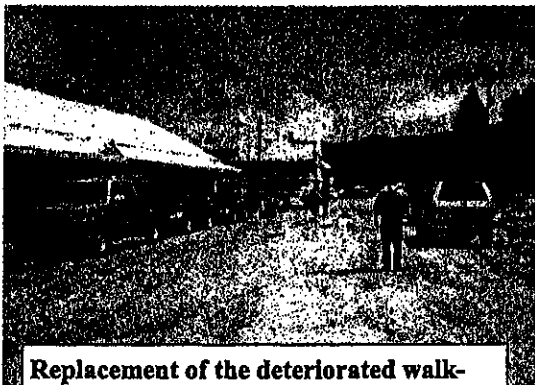
Replacement of the deteriorated walkways at the popular East Ely Railroad Museum is an urgent project for public safety and ADA compliance.

Patches hold part of the north walkway to the freight barn (above). Weathered walkways are easily broken and present a risk to visitors (right).

This project would replace the 8 by 340 foot northern walkway which is supported by a five foot framework. A second street level walkway would be removed, its framework replaced and new decking installed.

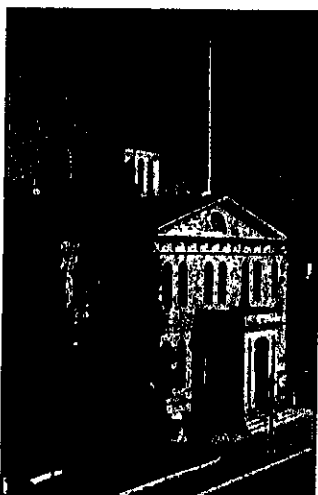
Physically challenged visitors sometimes wait up to 30 minutes to enter the museum by the freight elevator. Inconvenient and degrading, this situation also presents a serious public safety concern in the event of an emergency.

Install ramp or chair lift at the south or north side of the Nevada State Museum to allow improved access to disabled patrons
